RUBIDIUM AND CESIUM FREQUENCY STANDARDS STATUS AND PERFORMANCE ON THE GPS PROGRAM

M. Van Melle

Rockwell International Satellite Systems Division

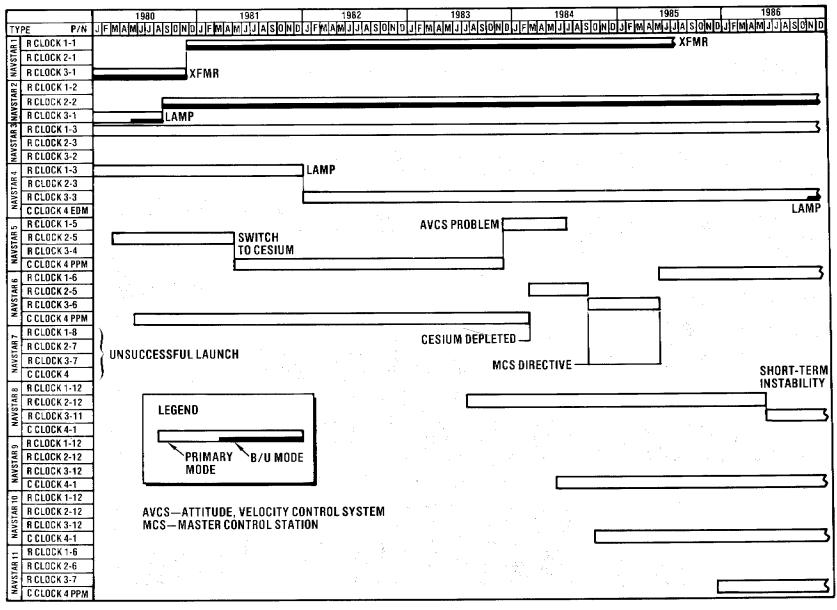
Figure 1. Navstar Clock Operating History

During the proposal phase of this program, the on-board frequency standards were considered the most critical item within the GPS navigational system for achieving user position accuracy. Therefore, a considerable amount of effort was devoted to the frequency standards. The initial GPS vehicles (GPS l through 3) incorporated three rubidium frequency standards, each with a backup mode, to minimize the risk to the GPS program on this critical item. This was achieved by operating a high performance VCXO without its rubidium reference. This design concept resulted in the redundancy potential of six frequency standards per vehicle. Later space vehicles, starting with GPS 4, included an additional cesium frequency standard, also with a backup VCXO mode. This extended redundancy was deemed necessary in lieu of the more conventional dual redundancy because if the rubidium loop failed, then the VCXO could be utilized as a backup device that would maintain frequency stability for a specific period of time, as required, to maintain navigational accuracy over the test area. The actual on-orbit GPS frequency standard operating history shown in Figure l illustrates the results of this hardware implementation.

As this clock program progressed, ten different models of the rubidium standards have evolved. The part numbers of the different models of each frequency standard are shown in Figure 1. The first rubidium standards on Navstars 1 and 2 accumulated a total of 44 months of operation with 6 failures, which necessitated switching to the backup modes (1978 through 1980). The backup mode operating time is 138 months and still counting. Navstar 1 was officially declared inoperable on December 1985 (7.7 years). Navstar 2 has two clocks with an operable backup mode, but no navigational or Kalman data is taken; just the power levels of L₁ and L₂ are monitored. The last 67 months of GPS rubidium clock operation on Navstars 4, 6, and 8 have seen one failure and three anomalies. The on-orbit chronology of events on the cesium frequency standards were very similar to the rubidium frequency standards. After an initial power supply problem, the preproduction models (PPM) have a total of 87 months of operation for three units with only one failure (depletion of cesium).
